Repairhints

3310/3330

NHM-5/6

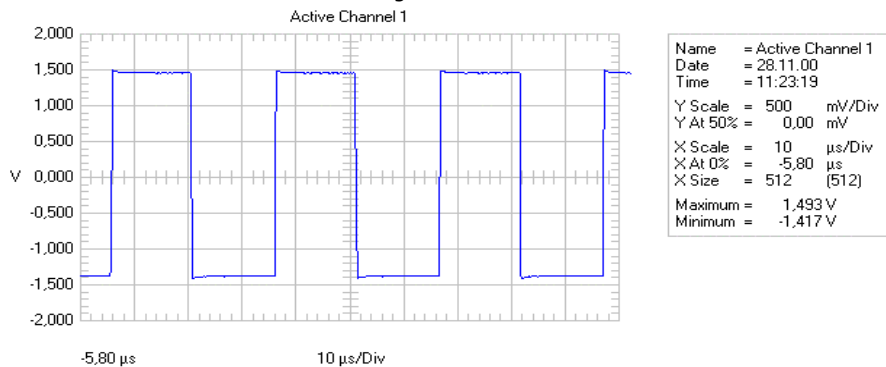
Figure 3-1

Amplitude of 32.768 kHz at C220 is 3 Vpp. If signal is not measurable check periphery of B200 like R211/212/214 and C229/230, change crystal B200 if necessary. If this does not solve the problem change CCONT N201. Remember to run energy management calibration after changing CCONT N201!

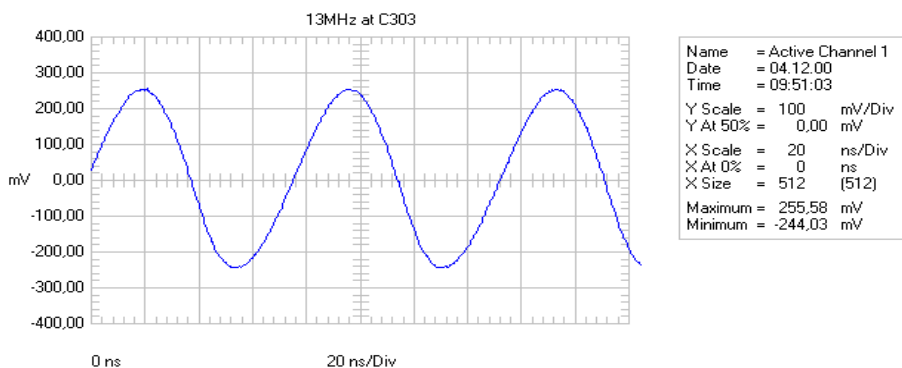
Figure 3-2

In case that the signal shown in figure 3-2 is not measurable, check voltages at reference oscillator G502: Check VCC 2.6 VDC at G502 pin 2, also check control voltage (AFC) at pin 1 which normally is 1.2 VDC. Note that control voltage may vary between 0.1 VDC and 2.3 VDC. Even without control voltage the oscillator must be able to work on a frequency around 26 MHz as shown in the Figure 3-3.
If this is not the case you have to change G502.

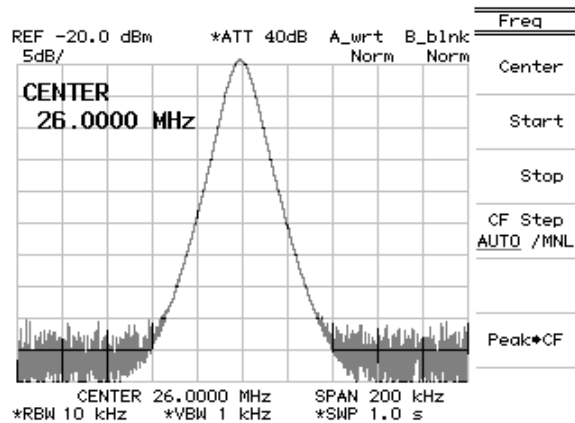
Figure 3-3

26 MHz reference clock at the output of G502: Amplitude is around -10 dBm.

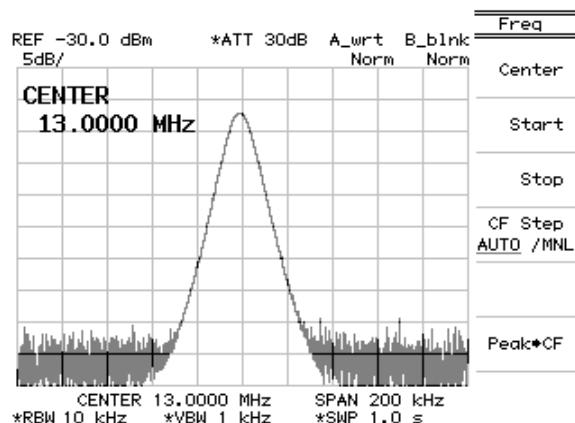
Figure 3-4

Amplitude of 13 MHz system clock at C559 is around -18 dBm.

If the signal shown above is not measurable, check VTCXO 2.7 VDC at C506/518. If both VTCXO and 26 MHz reference clock are ok but 13 MHz system clock at C559 is not measurable, you have to change Hagar N500. Remember to realign RX/TX-values after changing Hagar N500!

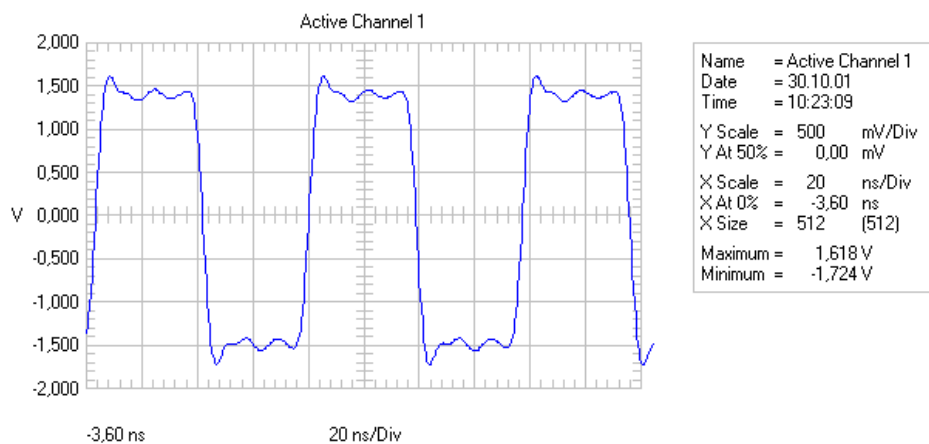
Figure 8-1

Probably COBBA N100 faulty or broken solderings under it – change COBBA and retune RX/TX-values.
If fault remains after changing COBBA, MAD or PCB faulty.

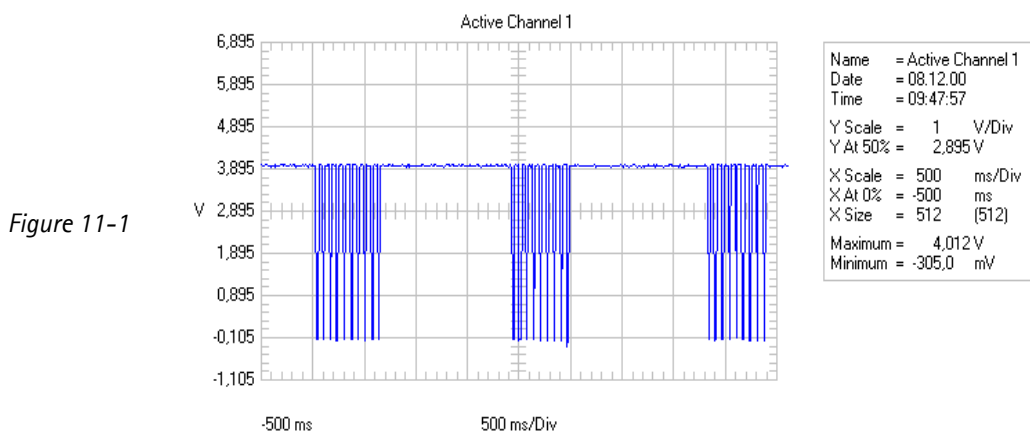
Figure 11-1

Check VB 3.6 VDC at pin 1 and VBB 2.8 VDC at pin 2 of N400.
Check vibra_cnt at pin 19 of N400. If signal is ok but vibra does not work, change N400, else there is a disconnection between D300 and N400 or MAD is faulty.

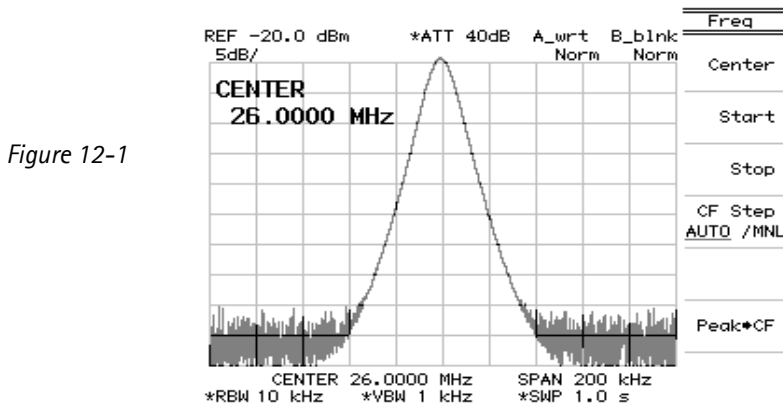
Figure 12-1

Amplitude of spectrum is approximately -10 dBm.

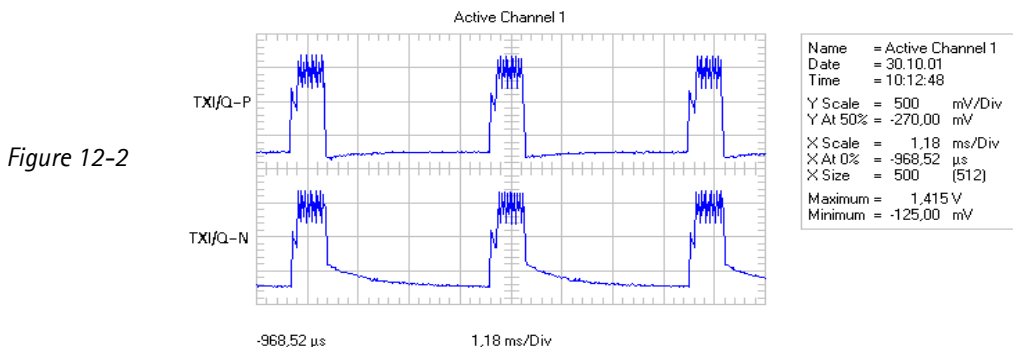
Figure 12-2

If TXIQ-signals at R541/548 are not measurable or somehow corrupted, check the following signals for COBBA N100: VBB 2.8 VDC at C119, VCOBBA 2.8 VDC at C116/117, VREF 1.5 VDC at C109 and 13 MHz COBBACKL at J317:

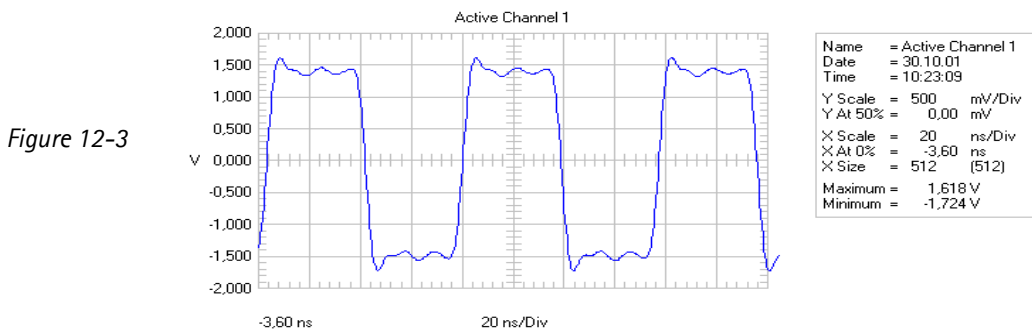
Figure 12-3

If the above mentioned signals for COBBA N100 are ok but TXIQ-signals are not measurable, probably COBBA is faulty or has broken solderings under it. Remove COBBA, rework oxidized pads if necessary with flux and solder and replace spare part with μBGA rework machine.

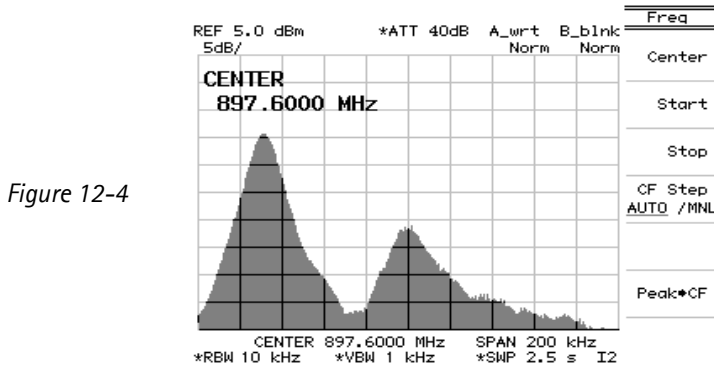
Figure 12-4

Amplitude of TX-spectrum at L514 is around 0 dBm. If this spectrum is not measurable, you have to check all signals, which HAGAR N500 needs to work:

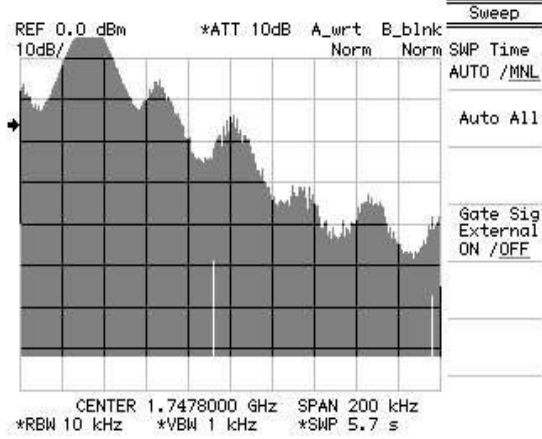
Figure 12-14

2) Spectrum with broken solderings under CCONT
Spectrum turns to picture 1 if CCONT is pushed careful with some nonmetallic item.

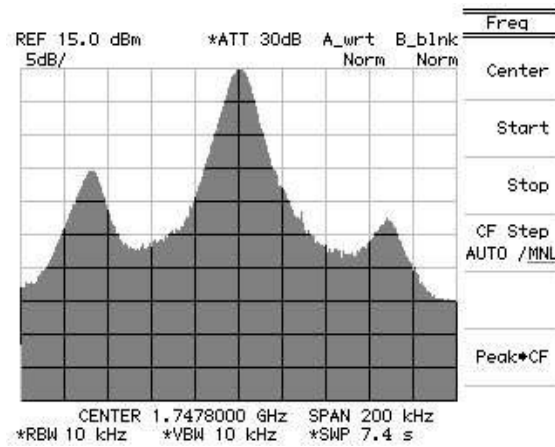
Figure 12-15

3) Spectrum of faulty COBBA

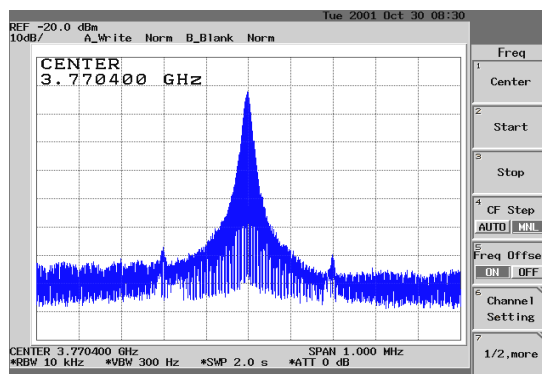
Figure 12-22

If SHF-oscillator does not work on expected frequency, check that voltage at C522 is 2.6 VDC. Also check control voltage at C558, which varies between 1.2 V and 3.3 VDC. If control voltage is 4.8 VDC, the oscillator is faulty or the control loop is open.

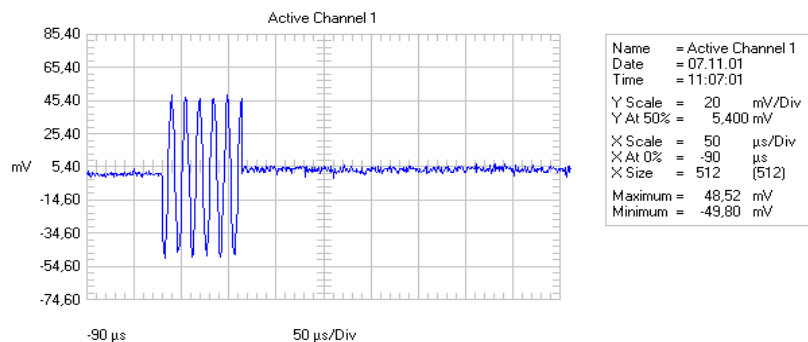
Figure 12-23

If signal is not ok, check C508 for shorts to ground, check resistance of R500 (4 x 100Ω) or change HAGAR N500.
