Repairhints

3310/3330

NHM-5/6

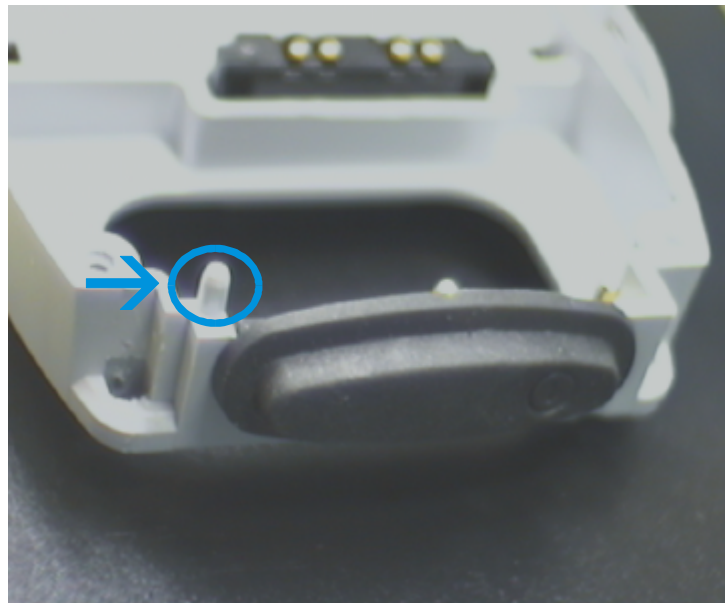
Figure 1-1

If customer criticizes bad removal of B-Cover cut away the guiding pin of the D-Cover (see *Figure 1-1*).
After this procedure it is necessary to assemble the phone with a torque screwdriver prepared for **30Ncm!**

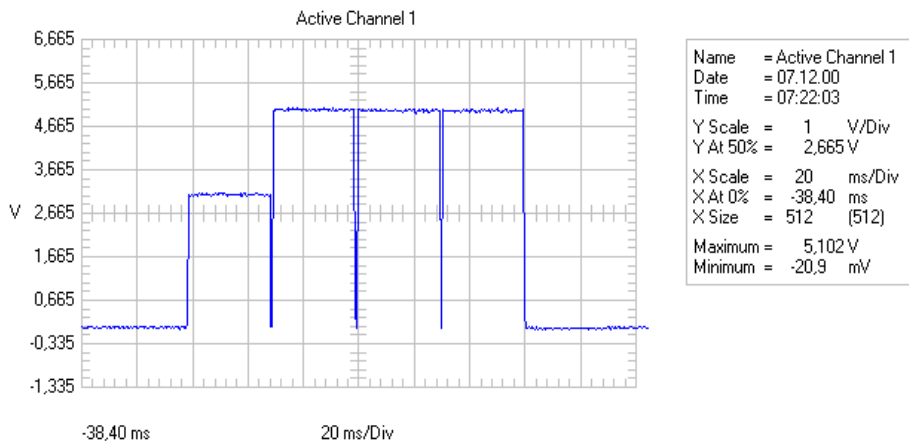
Figure 9-1

The easiest way to find out the reason for this fault is to check if every single SIMline is pulsed to the signal shown below after initializing the phone:

You can check this signal easily at the SIMreader's pogo-pins of the service-jig. The signal must be measurable at all pins except the ground pin.

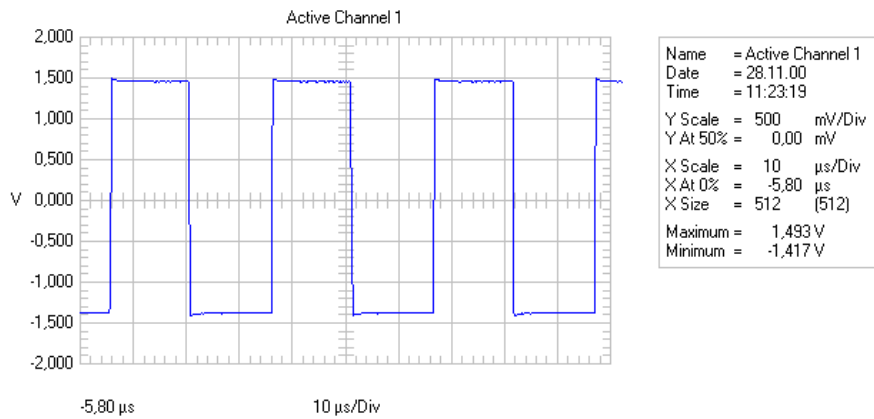
Figure 11-2

In case that clock time has to be corrected in short periods check amplitude and frequency of sleepclock-oscillator at C220.
 (3 Vpp squarewave at 32.768 kHz).
 If amplitude or frequency is not ok, change crystal B200.
 If fault persists, check parts around B200 as R211/212/214 and C229/230.

32.768 kHz measured at pad of C220 located towards crystal B200.

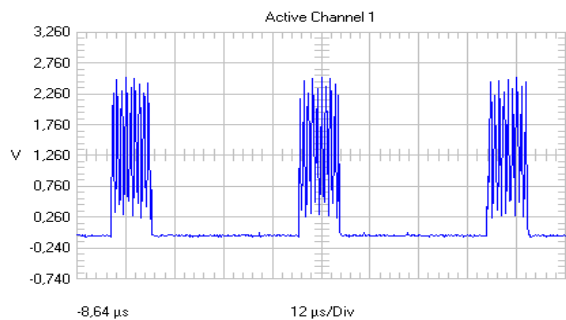
Figure 12-5

SCLK at R301:

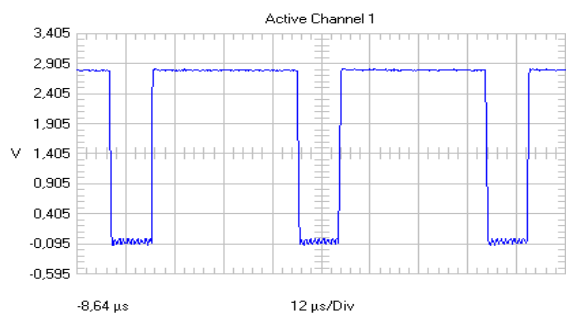
Figure 12-6

SENA at R301:

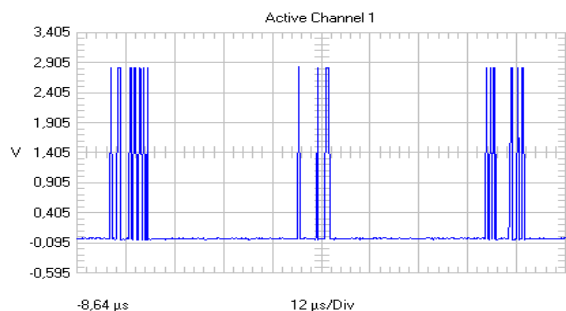
Figure 12-7

SDATA at R300:

Note that R300 is only assembled on PCB-version < UB4_11!
Further more these signals are necessary for a proper working HAGAR N500:

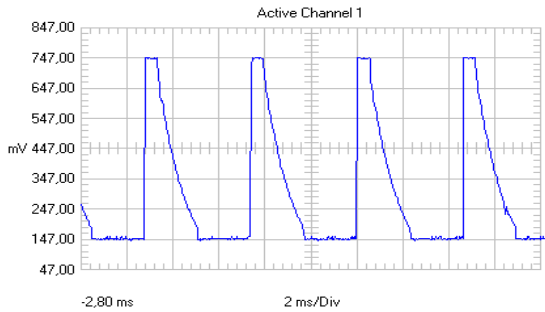
Figure 11-8

TXC measured at C542.

Note that the amplitude of TXC varies between 0.6 Vpp on power level 19 and 2 Vpp on power level 5.

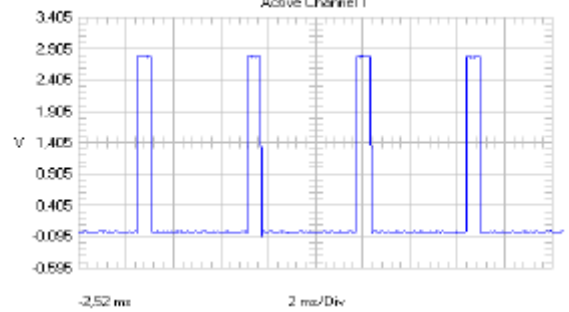
Figure 11.9

TXP 2.8Vpp measured at J503

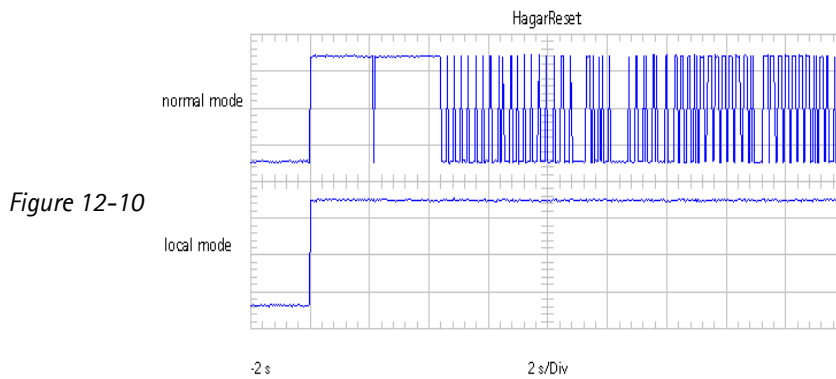
Figure 12-10

Also check HAGARReset at C540:

Remember that HAGARReset varies depending on the phone mode: while it is 2.8 VDC in local mode, it changes between 0 V (low) and 2.8 V (high) in normal mode!

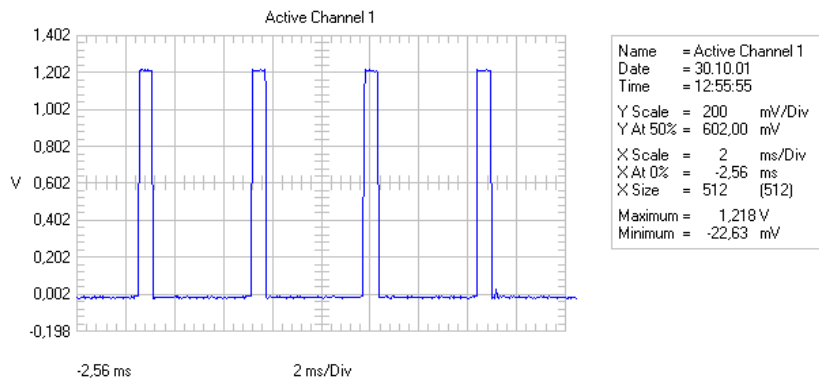
Figure 12-12

- Check VBATT 4 VDC at C570/572.
- Check Vapc at C565, which varies between 1.2 Vpp and 1.7 Vpp depending on TX-power level:

If these values are ok but amplitude of TX-spectrum at L515 pin 1 is too low, change the power amplifier N502.

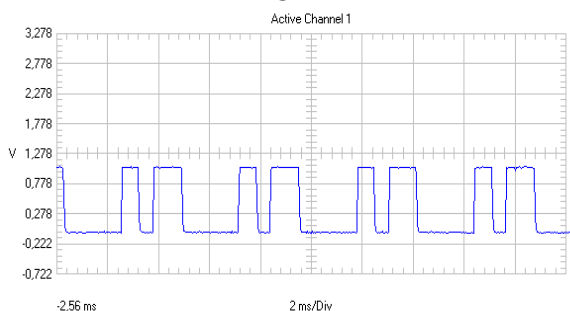
Figure 12.19

Check with an oscilloscope voltages at base (figure 12.19, 1.1 Vpp) and collector (figure 12.20, 2.6 Vpp) of V501, change V501 or N500 if necessary.

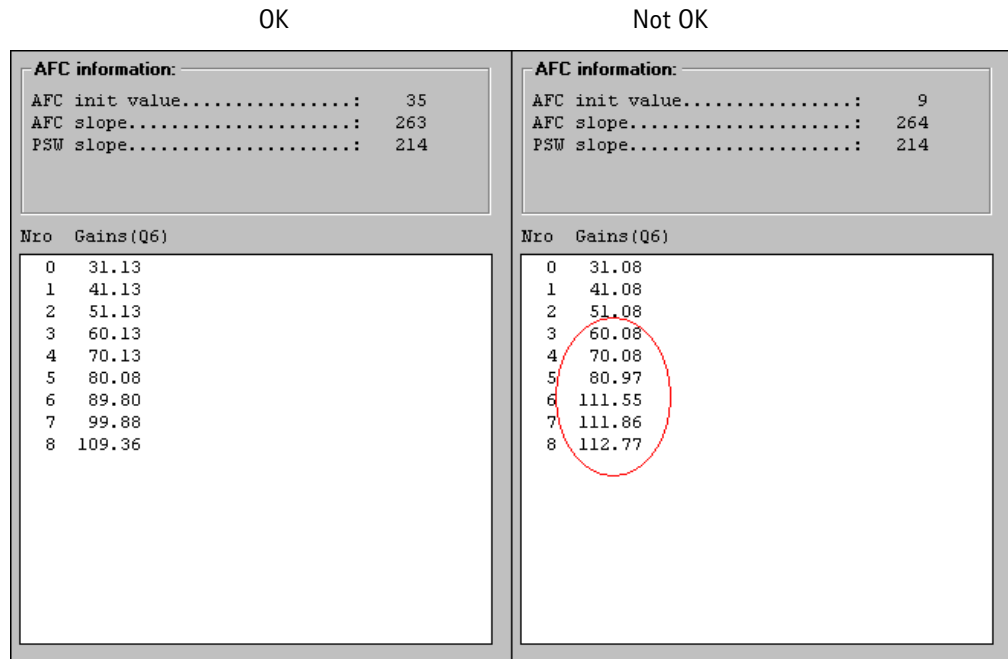
Figure 12-25

In case of this fault combined with an RX-calibration which works, but whose values are not ok (incorrect stepwidth as shown in figure 12-25), check signals at R500 and R504. The signals below were measured in RX-burstmode with an input level of -65 dB. Channel 1 shows the signals of a proper working phone while channel 2 shows the same signals of a phone in which C508 is faulty. R500 contains four resistors, so that you have to measure all four lines. It could happen that you will get the signal shown in channel 2 more than once. That means that more than one of the four capacitors in C508 are broken.
